## EASTHAM BUILDING AUDITS

*KMA audited the following buildings:*

# TOWN HALL

*AUDITED ON: MAY 6, 2021*

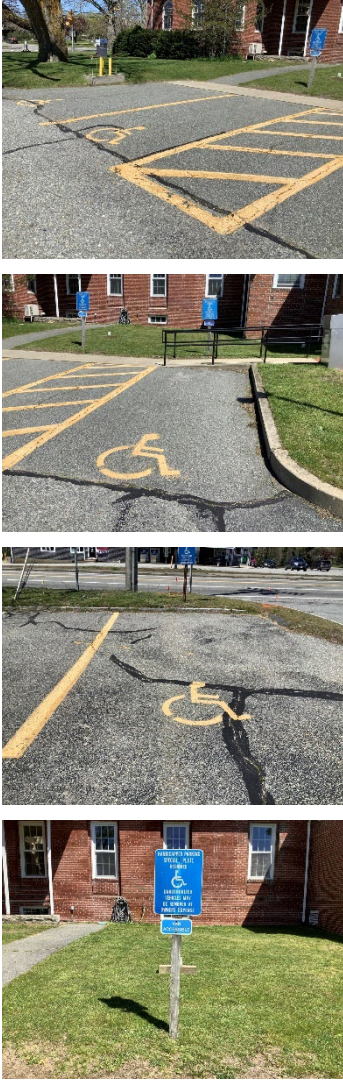
#	Barrier Statement	Photo	Proposed Mitigation	Cost
1.	<p><b>Parking Lot</b></p> <p>Some of the designated accessible parking spaces lack an adjacent access aisle.</p> <p>The designated van accessible aisle is &lt;60" wide, measured centerline to centerline.</p> <p>The isolated accessible parking space have slopes &gt;2%, @ 4.1%</p> <p>The designated accessible parking space facing State Highway is not located on the shortest accessible route to the accessible entrance.</p> <p>The accessible parking signs are mounted &lt;60" AFF, measured to the bottom of the sign, @ 40" AFF.</p>

<p>Restripe the pavement markings in the group of three parking spaces and associated access aisles. Unit Cost: \$150 per space or aisle Quantity: 5 (3 spaces, 2 aisles)</p> <p>Restripe and relocate the space closest to the accessible entrance, as well as its associated sign and access aisle, to make 1 van accessible space. Unit Cost: \$300 per space or aisle Quantity: 2 (1 space, 1 aisle)</p> <p>Install a sign with the International Symbol of Accessibility at 60" AFF minimum, measured to the bottom of the sign. Include a van accessible sign where applicable. Unit Cost: \$100 ea. Quantity: 4</p>	\$1,750

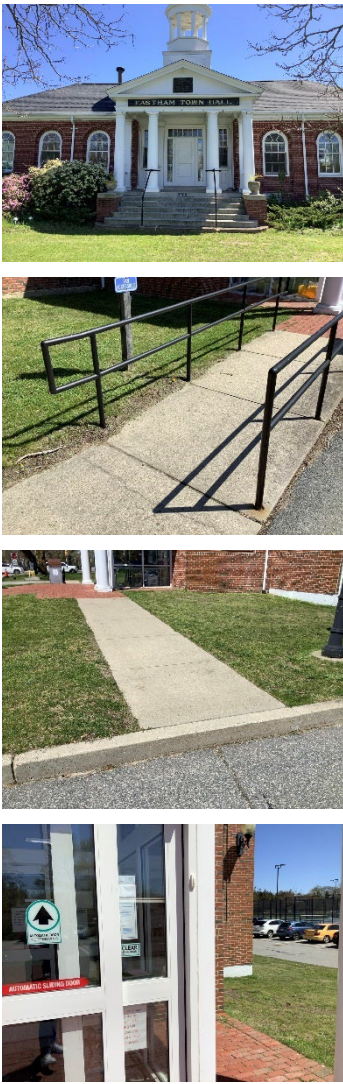
<p>2.</p>	<p><b>Main Entrance</b></p> <p>The inaccessible front entrance lacks directional signage to the accessible entrance.</p> <p>The transition from the accessible parking to the walkway has changes in level &gt;1/4" due to variations in the paver surface.</p> <p>The lower handrails on the ramp are not 18"-20" measured to the top of the gripping surface, @ 21" AFF.</p> <p>The bottom handrails on the ramp are not continuous.</p> <p>The ramp lacks level landing at the top, @ 6.2%.</p> <p>The accessible route from the Field of Dreams accessible parking to the accessible entrance has excessive running slopes &gt;5% and is not treated as ramp, @ 7%.</p> <p>The accessible route from the Field of Dreams accessible parking to the accessible entrance lacks a curb ramp.</p> <p>The doorbell at the front entrance is installed &gt;48" AFF, @ 66" AFF to the highest operable part.</p>

<p>Provide directional signage to the accessible entrance. Unit Cost: \$100 ea. Est. Quantity: 1</p> <p>Regrade the walkway. Unit Cost: \$25/SF Est. Quantity: 63 SF</p> <p>Install compliant handrails on both sides of the ramp. Unit Cost: \$50/LF Est. Quantity: 30 LF</p> <p>Regrade the ramp landing. Unit Cost: \$25/SF Quantity: 20 SF</p> <p>Install compliant handrails on both sides of the walkway from the Field of Dreams accessible parking to the accessible entrance. Unit Cost: \$50/LF Est. Quantity: 50 LF</p> <p>Install a compliant curb ramp. Unit Cost: \$2,500 ea. Quantity: 1</p> <p>Lower the doorbell no higher than 48" AFF. Unit Cost: \$250 ea. Quantity: 1</p>	<p>\$8,925</p>

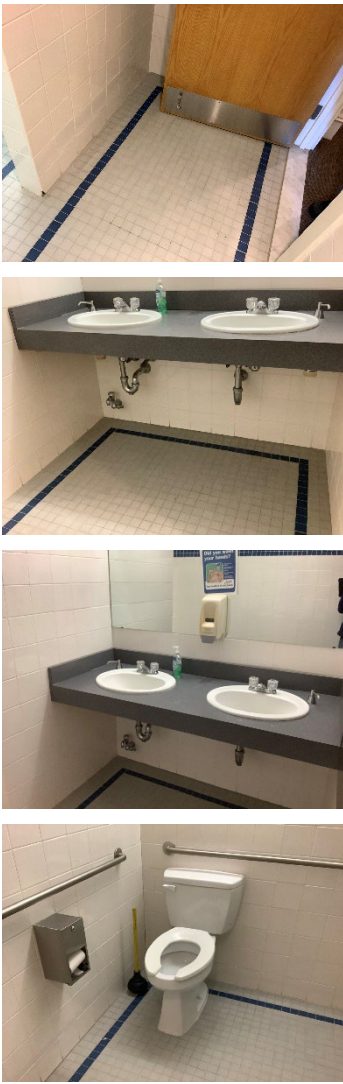
<p>5.</p>	<p><b>Public Women's Toilet Room (Lower Level)</b></p> <p>The pull-side door maneuvering clearance is &lt;60" perpendicular to the doorway, @ 45.5".</p> <p>The sink pipes lack insulation.</p> <p>The mirror is &gt;40" AFF, @ 43' AFF, measured to the bottom of the reflective surface.</p> <p>The flush valve is not located on the open side of the toilet.</p>

<p>Install an automatic door opener. Unit Cost: \$2,500 ea. Quantity: 1</p> <p>Insulate the pipes underneath the sink. Unit Cost: \$50 ea. Quantity: 2</p> <p>Lower the mirror. Unit Cost: \$50 ea. Quantity: 1</p> <p>Reposition the flush valve or install an automatic flush control. Unit Cost: \$1,000 ea. Quantity: 1</p>	<p>\$3,650</p>
-----------	--	---	---	----------------

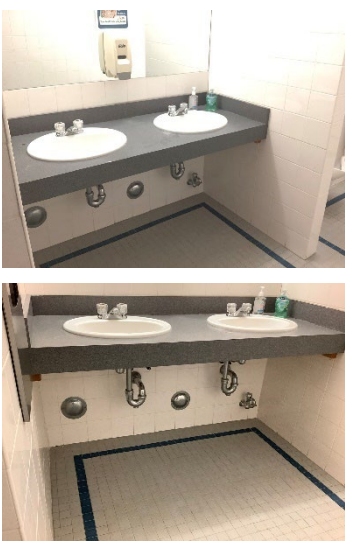
<p>6.</p>	<p><b>Public Men's Toilet Room (Lower Level)</b></p> <p>The pull-side door maneuvering clearance is &lt;60" perpendicular to the doorway, @ 45.5".</p> <p>The sink pipes lack insulation.</p> <p>The mirror is &gt;40" AFF, @ 43' AFF, measured to the bottom of the reflective surface.</p>

<p>Install an automatic door opener. Unit Cost: \$2,500 ea. Quantity: 1</p> <p>Insulate the pipes underneath the sink. Unit Cost: \$50 ea. Quantity: 2</p> <p>Lower the mirror. Unit Cost: \$50 ea. Quantity: 1</p>	<p>\$2,650</p>
<p>7.</p>	<p><b>Small Hearing Room (Lower Level)</b></p> <p>The door maneuvering clearance is &lt;18" on the latch pull-side for a forward approach, @ 16.5".</p>

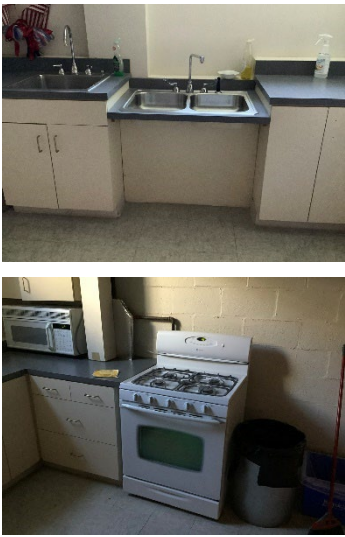
<p>8.</p>	<p><b>Kitchen</b></p> <p>The sink lacks the required knee and toe clearance for a forward approach, @ 10.5" depth.</p> <p>The cooktop lacks the required knee and toe clearance for a forward approach.</p>

<p>Modify the sink to provide the required knee / toe clearance. Unit Cost: \$500 ea. Quantity: 1</p> <p>Provide an accessible cooktop. Unit Cost: \$750 ea. Quantity: 1</p>	<p>\$1,250</p>
<p>9.</p>	<p><b>Counters (First Floor)</b></p> <p>All the counters are &gt;36" AFF, @ 42" AFF. Computers are mounted &gt;36" AFF.</p>

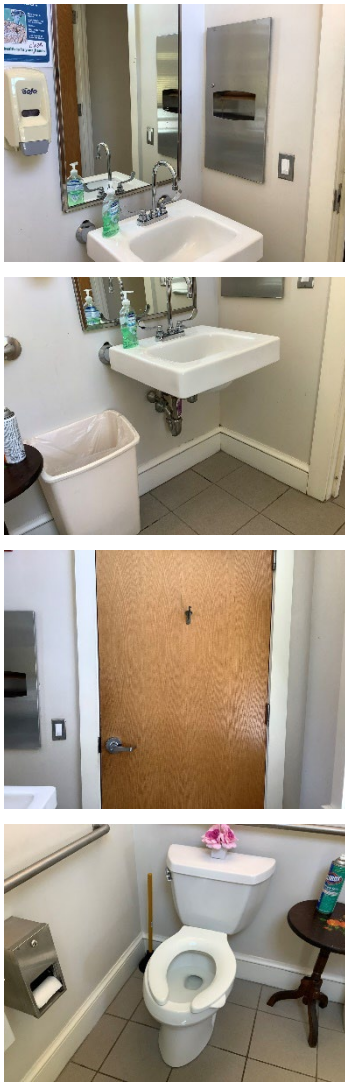
<p>10.</p>	<p><b>Women's Employee Toilet Room (First Floor)</b></p> <p>The door maneuvering clearance is &lt;18" on the latch pull-side for a forward approach, @ 7" due to the sink.</p> <p>The paper dispenser is mounted &gt;48", @ 53" AFF.</p> <p>The sink pipes lack insulation.</p> <p>The coat hook is mounted &gt;48" AFF, @ 63" AFF.</p> <p>The flush valve is not located on the open side of the toilet.</p>

<p>Install an automatic door opener. Unit Cost: \$2,500 ea. Quantity: 1</p> <p>Relocate the paper towel dispenser. Unit Cost: \$50 ea. Quantity: 1</p> <p>Insulate the pipes underneath the sink. Unit Cost: \$50 ea. Quantity: 1</p> <p>Install a coat hook mounted no higher than 48" AFF. Unit Cost: \$50 ea. Quantity: 1</p> <p>Reposition the flush valve or install an automatic flush control. Unit Cost: \$1,000 ea. Quantity: 1</p>	<p>\$3,650</p>
------------	---	---	--	----------------

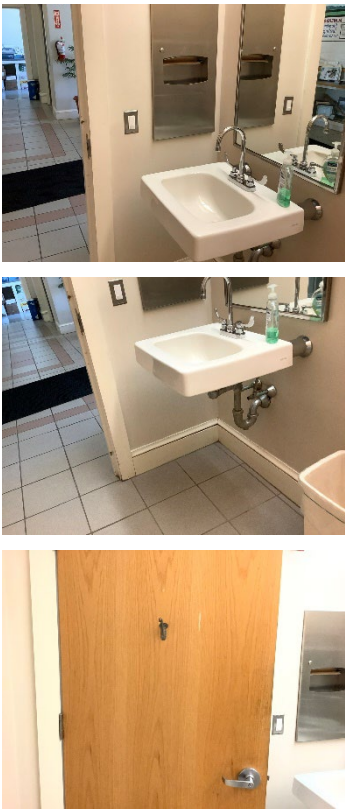
11.	<p><b>Men's Employee Toilet Room (First Floor)</b></p> <p>The door maneuvering clearance is &lt;18" on the latch pull-side for a forward approach, @ 7" due to the sink.</p> <p>The paper dispenser is mounted &gt;48", @ 53" AFF.</p> <p>The sink pipes lack insulation.</p> <p>The coat hook is mounted &gt;48" AFF, @ 63" AFF.</p>

<p>Install an automatic door opener. Unit Cost: \$2,500 ea. Quantity: 1</p> <p>Relocate the paper towel dispenser. Unit Cost: \$50 ea. Quantity: 1</p> <p>Insulate the pipes underneath the sink. Unit Cost: \$50 ea. Quantity: 1</p> <p>Install a coat hook mounted no higher than 48" AFF. Unit Cost: \$50 ea. Quantity: 1</p>	\$2,650
<b>TOTAL FOR TOWN HALL:</b>				<b>\$37,475</b>

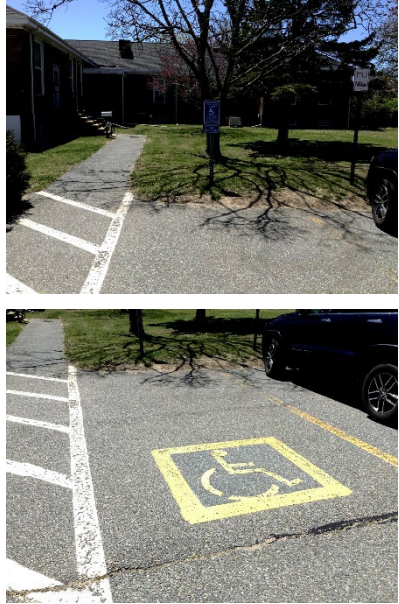
#	<i>Barrier Statement</i>	<i>Photo</i>	<i>Proposed Mitigation</i>	<i>Cost</i>
1.	<p><b>Parking Lot near Main Entrance</b></p> <p>The accessible parking signs are mounted &lt;60" AFF, measured to the bottom of the sign.</p> <p>The accessible parking space and its associated access aisle have changes in level &gt;1/4".</p>

<p>Install a van accessible parking sign with the International Symbol of Accessibility at 60" AFF minimum, measured to the bottom of the sign.</p> <p>Unit Cost: \$100 ea. Quantity: 1</p> <p>Regrade the accessible parking space and its associated access aisle.</p> <p>Unit Cost: \$1,500 per space or aisle Quantity: 2 (1 space + 1 aisle)</p>	\$3,100

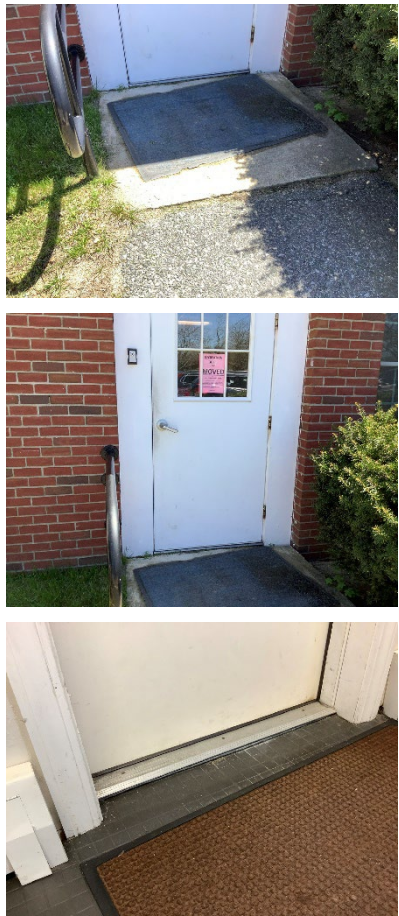
<p>2.</p>	<p><b>Main Entrance</b></p> <p>The walkway has changes in level <math>&gt;1/4</math>" due to variations in the paver surface.</p> <p>The door maneuvering clearance is <math>&lt;18</math>" on the latch pull-side for a forward approach, @ 14" due to the handrail.</p> <p>The threshold is <math>&gt;1/2</math>" and not beveled at maximum 1:2, @ 1 1/4".</p>

<p>Regrade the walkway. Unit Cost: \$25/SF Est. Quantity: 16 SF</p> <p>Relocate the handrail. Unit Cost: \$50 ea. Quantity: 1</p> <p>Replace the threshold. Unit Cost: \$250 ea. Quantity: 1</p>	<p>\$700</p>
<p><b>TOTAL FOR TOWN HALL ANNEX:</b></p>				<p><b>\$3,800</b></p>

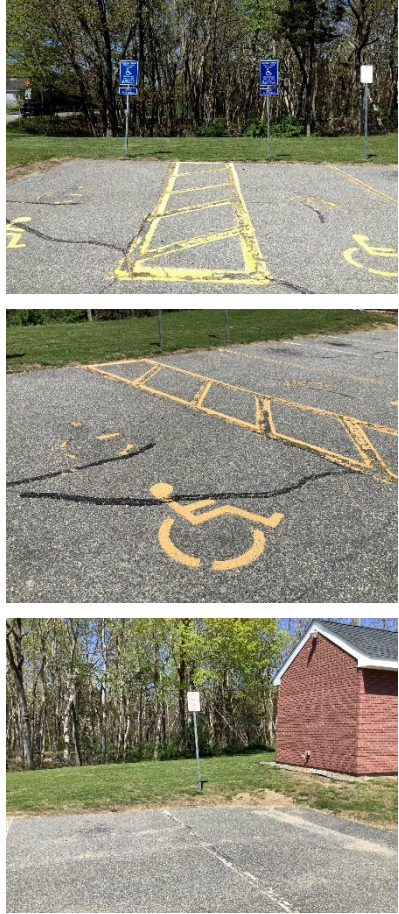
#	Barrier Statement	Photo	Proposed Mitigation	Cost
1.	<p><b>Parking Lot</b></p> <p>The designated van accessible aisle is &lt;60" wide, @ 54" measured centerline to centerline.</p> <p>Some of the accessible parking spaces have slopes &gt;2%, @ 2.5%.</p> <p>There are no designated accessible visitor parking spaces provided.</p>

<p>Regrade and restripe the existing accessible parking spaces and associated access aisles.            Unit Cost: \$1,500 per space or aisle            Quantity: 3 (2 spaces + 1 aisle)</p> <p>Stripe a portion of the parking lot to add one van accessible space, as well as its associated sign and access aisle. Include signage for visitor parking.            Unit Cost: \$300 per space or aisle            Quantity: 2 (1 space + 1 aisle)</p>	\$5,100

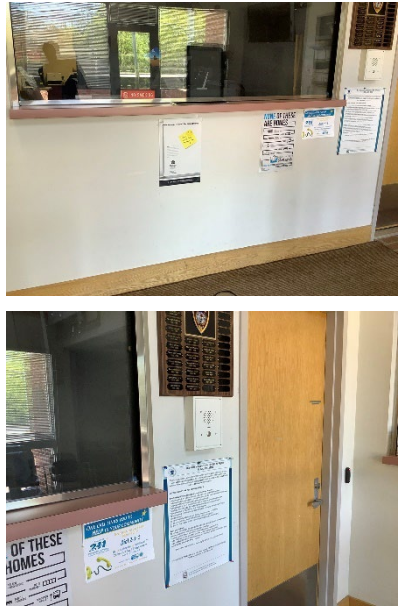
<p>2.</p>	<p><b>Main Entrance</b></p> <p>Some portions of the walkway from the parking lot to the main entrance have running slopes &gt; 5%, @ 5.5%, and are not treated as a ramp.</p> <p>The door lacks a level landing, @ 3%.</p>	 	<p>Regrade the walkway. Unit Cost: \$25/SF Est. Quantity: 235 SF</p> <p>Regrade the door landing. Unit Cost: \$1,000 Quantity: 1</p>	<p>\$6,875</p>
<p>3.</p>	<p><b>Lobby</b></p> <p>The reception counter is &gt;36" AFF, @ 48" AFF.</p> <p>The intercom control is mounted &gt;48" AFF, @ 56" AFF to the highest operable part.</p>

<p>Lower a 36" wide portion of the counter to 36" max. AFF. Unit Cost: \$750 Quantity: 1</p> <p>Lower the intercom control to no higher than 48" AFF. Unit Cost: \$250 ea. Quantity: 1</p>	<p>\$1,000</p>

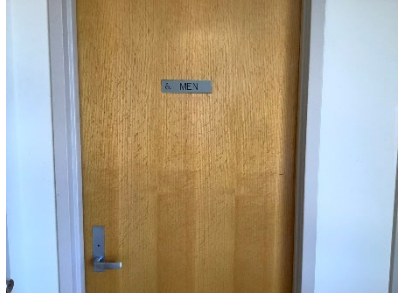
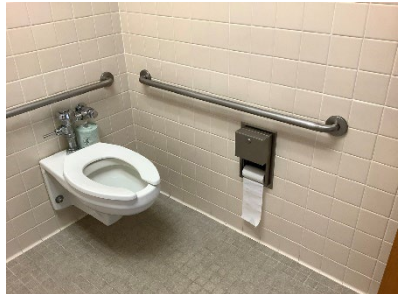
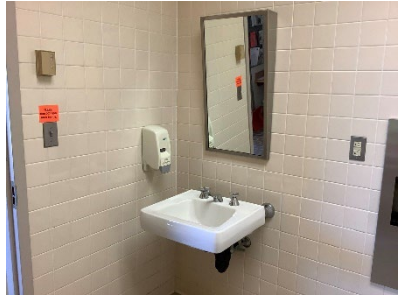
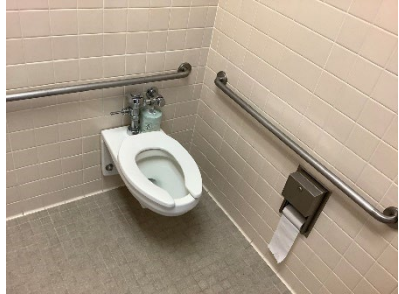
<p>4.</p>	<p><b>Public Men's Single-user Toilet Rooms in Lobby</b></p> <p>There is no tactile/ Braille signage mounted on the latch side of the door.</p> <p>The side grab bar extends &lt;54" from the rear wall, @ 48".</p> <p>The mirror is &gt;40" AFF, @ 42" AFF, measured to the bottom of the reflective surface.</p> <p>The toilet centerline is not 16"-18" from the side wall, @ 18 ¼".</p>

<p>Install compliant tactile/ Braille signage on the latch side of the door. Coordinate with location and height requirements. Unit Cost: \$100 ea. Est. Quantity: 1</p> <p>Install a 42" min. side grab bar, located 12" from the interior corner of the wall. Unit Cost: \$50 ea. Quantity: 1</p> <p>Lower the mirror. Unit Cost: \$50 ea. Quantity: 1</p> <p>Reposition the toilet. Unit Cost: \$1,500 ea. Quantity: 1</p>	<p>\$1,700</p>
-----------	---	--	---	----------------

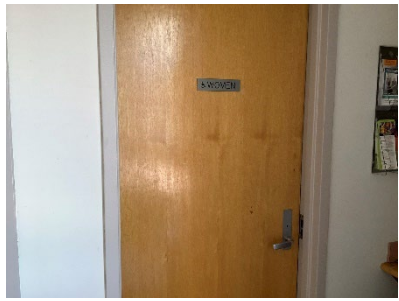
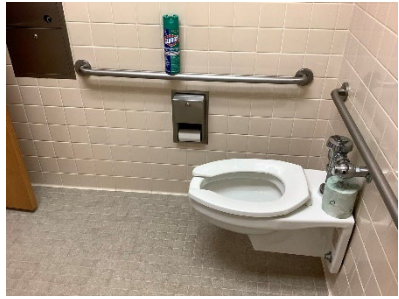
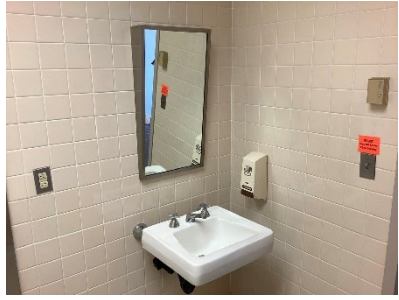
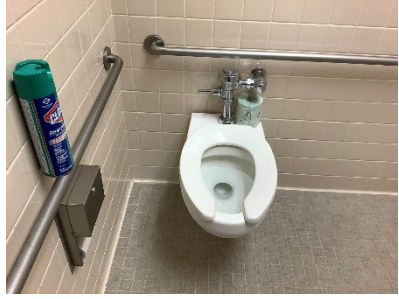
<p>5.</p>	<p><b>Public Women's Single-user Toilet Rooms in Lobby</b></p> <p>There is no tactile/ Braille signage mounted on the latch side of the door.</p> <p>The side grab bar extends &lt;54" from the rear wall, @ 48".</p> <p>The mirror is &gt;40" AFF, @ 42" AFF, measured to the bottom of the reflective surface.</p> <p>The toilet centerline is not 16"-18" from the side wall, @ 18.5".</p> <p>The toilet paper dispenser is not located 7"-9" from the front of the toilet.</p> <p>The flush valve is not located on the open side of the toilet.</p>

<p>Install compliant tactile/ Braille signage on the latch side of the door. Coordinate with location and height requirements. Unit Cost: \$100 ea. Est. Quantity: 1</p> <p>Install a 42" min. side grab bar, located 12" from the interior corner of the wall. Unit Cost: \$50 ea. Quantity: 1</p> <p>Lower the mirror. Unit Cost: \$50 ea. Quantity: 1</p> <p>Reposition the toilet. Unit Cost: \$1,500 ea. Quantity: 1</p> <p>Relocate the toilet paper dispenser. Unit Cost: \$50 ea. Quantity: 1</p> <p>Reposition the flush valve or install an automatic flush control. Unit Cost: \$1,000 ea. Quantity: 1</p>	<p>\$2,750</p>

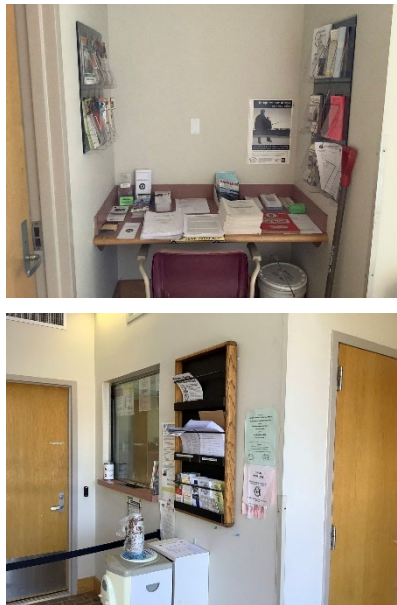
<p>6.</p>	<p><b>Brochures</b></p> <p>Brochures are mounted &gt;48" AFF, @ 69"- 79" AFF.</p>

<p>Relocate the brochures within an accessible reach range.</p> <p>Unit Cost: \$250 Quantity: 3</p>	<p>\$750</p>
<p>7.</p>	<p><b>Holding Cells</b></p> <p>The sink lacks the required knee clearance for a forward approach.</p> <p>The toilet lacks the required grab bars.</p> <p><i>Note: At least one accessible cell per holding classifications must be provided.</i></p>

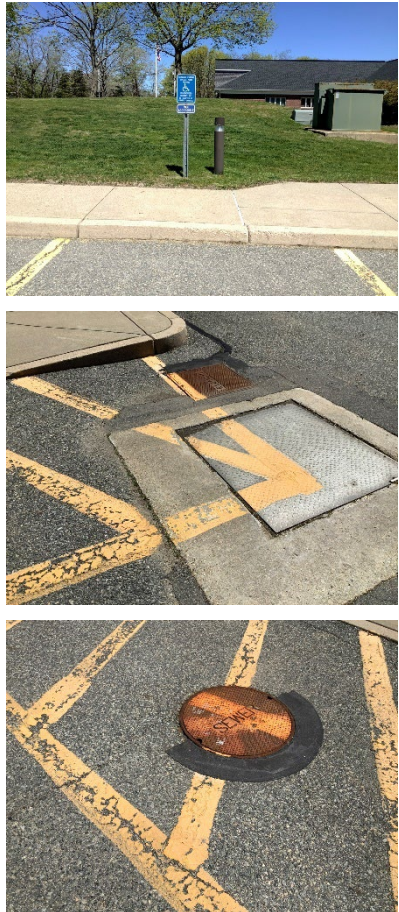
#	Barrier Statement	Photo	Proposed Mitigation	Cost
1.	<p><b>Parking Lot</b></p> <p>The accessible parking sign is mounted &lt;60" AFF, measured to the bottom of the sign, @ 40" AFF.</p> <p>The access aisle has changes in level &gt;1/4" due to variations in the paver surface and to sewer covers.</p>

<p>The top photo shows a blue accessible parking sign mounted on a post that is too low to the ground. The middle photo shows a raised curb at the edge of a parking space. The bottom photo shows a circular sewer cover in the middle of a parking aisle.</p>	<p>Install a van accessible parking sign with the International Symbol of Accessibility at 60" AFF minimum, measured to the bottom of the sign.            Unit Cost: \$100 ea.            Quantity: 1</p> <p>Regrade the aisle.            Unit Cost: \$1,500 per space or aisle            Quantity: 1 space</p>	\$1,600

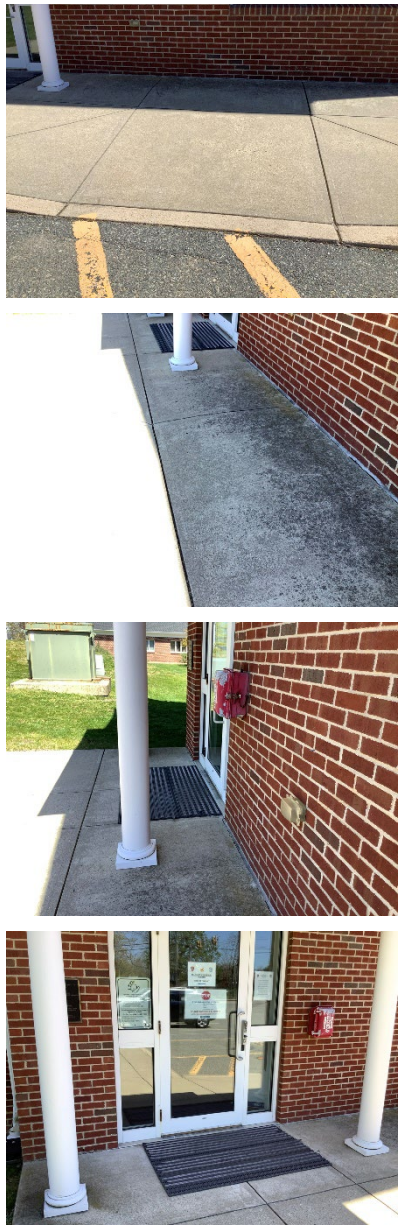
<p>2.</p>	<p><b>Main Entrance</b></p> <p>The slope of the curb ramp is &gt;8.3%, @ 11.2%.</p> <p>The curb ramp lacks a level landing.</p> <p>The walkway is &lt;36" wide due to a column.</p> <p>The door lacks a level landing, @ 5%.</p> <p>The column blocks the clear floor space for the emergency alarm.</p> <p>The emergency alarm box protrudes &gt;4" into the circulation space.</p> <p>The door requires &gt;5lbs of force to open.</p>

<p>Rebuild the curb ramp. Unit Cost: \$1,250 ea. Quantity: 1</p> <p>No separate mitigation required. Once the curb ramp above is rebuilt, the accessible route will no longer be narrowed by the column. Unit Cost: \$0 Quantity: N/A</p> <p>Regrade the door landing. Unit Cost: \$1,000 ea. Quantity: 1</p> <p>Relocate the emergency alarm box. Unit Cost: \$250 ea. Quantity: 1</p> <p>Adjust the door closer. Unit Cost: \$50 ea. Est. Quantity: 1</p>	<p>\$2,550</p>
-----------	--	---	---	----------------

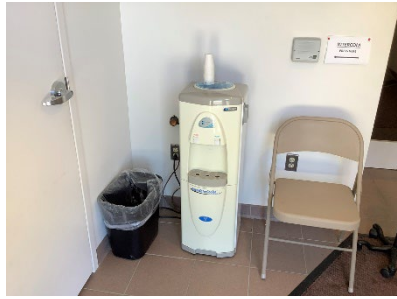
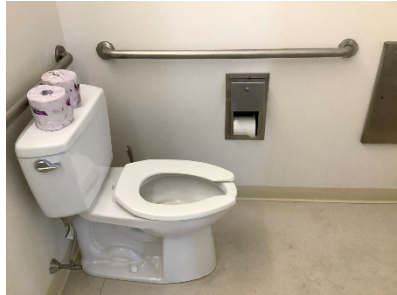
<p>3.</p>	<p><b>Public Single-User Toilet Room</b></p> <p>The door maneuvering clearance is &lt;18” on the latch pull-side for a forward approach due to the water cooler and other furniture elements.</p> <p>There is no tactile/ Braille signage mounted on the latch side of the door.</p> <p>The side grab bar extends &lt;54” from the rear wall, @ 49”.</p> <p>The toilet paper dispenser is not located 7”-9” from the front of the toilet.</p>

<p>Relocate the water cooler. Unit Cost: \$250 ea. Quantity: 1</p> <p>Install compliant tactile/ Braille signage on the latch side of the door. Coordinate with location and height requirements. Unit Cost: \$100 ea. Est. Quantity: 1</p> <p>Install a 42” min. side grab bar, located 12” from the interior corner of the wall. Unit Cost: \$50 ea. Quantity: 1</p> <p>Relocate the toilet paper dispenser. Unit Cost: \$50 ea. Quantity: 1</p>	<p>\$450</p>

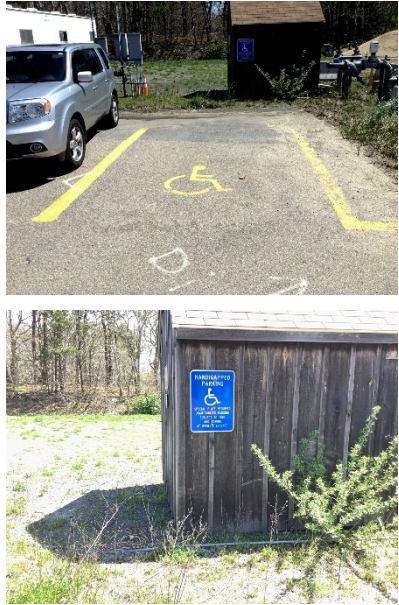
#	Barrier Statement	Photo	Proposed Mitigation	Cost
1.	<p><b>Parking Lot</b></p> <p>The designated accessible parking space lacks an adjacent access aisle.</p> <p>The accessible parking sign is mounted &lt;60" AFF, @ 44" AFF measured to the bottom of the sign.</p>

<p>Restripe the pavement markings in the parking space and associated access aisle. Unit Cost: \$150 per space or aisle Quantity: 2 (1 space + 1 aisle)</p> <p>Install a van accessible sign with the International Symbol of Accessibility at 60" AFF minimum, measured to the bottom of the sign. Unit Cost: \$100 ea. Quantity: 1</p>	\$400
2.	<p><b>Exterior Wooden Handrails</b></p> <p>The wooden handrail surfaces are abrasive, due to its deterioration.</p>

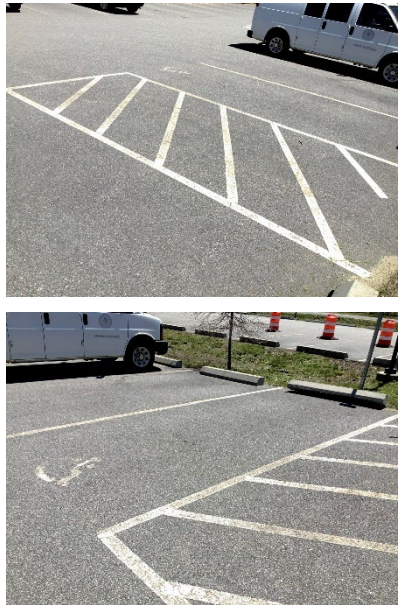
#	<i>Barrier Statement</i>	<i>Photo</i>	<i>Proposed Mitigation</i>	<i>Cost</i>
1.	<p><b>Parking Lot</b></p> <p>There is an insufficient number of van accessible parking spaces. For a parking lot with two accessible spaces, one must be van accessible.</p> <p>The accessible parking spaces and its associated access aisle have slopes &gt;2%, @ 2.5%.</p>

<p>Restripe a portion of the parking lot to add 1 van accessible space, as well as its associated sign and access aisle. Unit Cost: \$300 per space or aisle Quantity: 2 (1 space + 1 aisle)</p> <p>Regrade and restripe the existing accessible parking spaces and their associated access aisle. Unit Cost: \$1,500 per space or aisle Quantity: 3 (2 spaces + 1 aisle)</p>	\$5,100

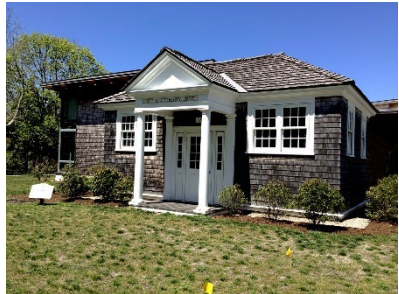
2.	<p><b>Library Historic Entrance</b></p> <p>The inaccessible front entrance lacks directional signage to the accessible entrance.</p>

<p>Provide directional signage to the accessible entrance. Unit Cost: \$100 ea. Est. Quantity: 1</p>	\$100

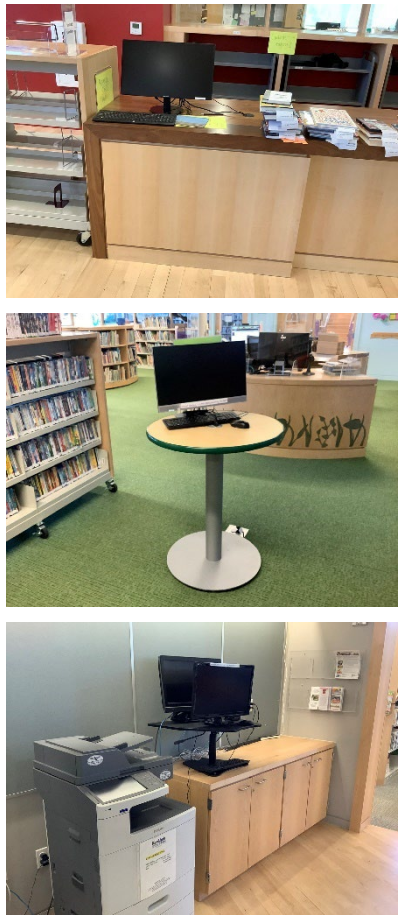
<p>6.</p>	<p><b>Work Surfaces</b></p> <p>Some computer tables lack the required knee and toe clearance for a forward approach.</p> <p>The computer associated to the printer is mounted &gt;36" AFF.</p>

<p>Provide at least one computer table, and no less than 5% of the total number of tables, that provides compliant knee and toe clearance.</p> <p>Unit Cost: \$250 ea. Est. Quantity: 1</p> <p>Provide a computer within accessible reach range.</p> <p>Unit Cost: \$250 ea. Quantity: 1</p>	<p>\$500</p>
<p>7.</p>	<p><b>Door Maneuvering Clearance - Conference Room</b></p> <p>The door maneuvering clearance is &lt;18" on the latch pull-side for a forward approach, due to the recessed door.</p>

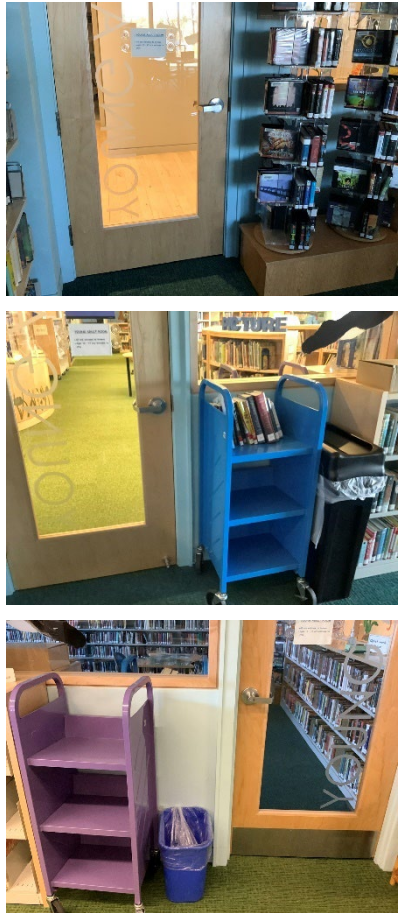
<p>8.</p>	<p><b>Door Maneuvering Clearance (Typical)</b></p> <p>Some of the doors lack the required maneuvering clearances on both the pull-side and push-side for a forward approach, due to the presence of furniture elements and shelves.</p>

<p>Relocate the shelves to provide a compliant door maneuvering clearance.</p> <p>Unit cost: \$0</p> <p>Quantity: N/A</p>	<p>\$0</p>
<p>9.</p>	<p><b>Drinking Fountain</b></p> <p>There is no “hi” drinking fountain for standing persons provided.</p>

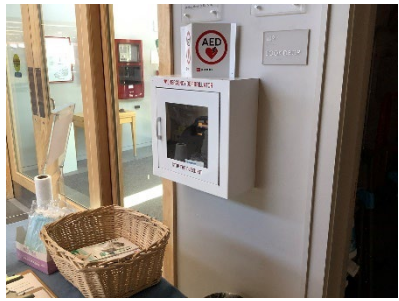
<p>10.</p>	<p><b>Defibrillator</b></p> <p>The defibrillator box protrudes &gt;4" at a height &gt;27" AFF, @ 7" at 34" AFF.</p>

<p>Relocate the defibrillator box. Unit Cost: \$50 ea. Quantity: 1</p>	<p>\$50</p>
<p>11.</p>	<p><b>Women's Multi-user Toilet Room (Ground Floor)</b></p> <p>The paper towel dispenser protrudes &gt;4" at a height &gt;27" AFF, @ 7" at 39" AFF.</p> <p>The coat hook is mounted &gt;48" AFF, @ 54" AFF.</p> <p>The side grab bar extends &lt;54" from the rear wall, @ 48".</p> <p>The rear grab bar extends &lt;12" from the centerline of the water closet.</p>

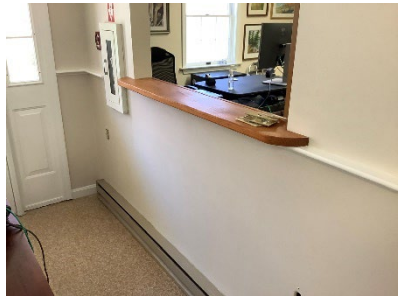
<p>Build a ramp. Unit Cost: \$5,000 ea. Quantity: 1</p>	<p>\$5,000</p>
<p>17.</p>	<p><b>Service Counter (Ground Floor)</b></p> <p>The service counter is &gt;36" AFF, @ 43" AFF.</p>

<p>Lower a 36" portion of the counter to max. 36" AFF. Unit Cost: \$3,000 ea. Quantity: 1</p>	<p>\$3,000</p>
<p>18.</p>	<p><b>Computer Room (Ground Floor)</b></p> <p>The door provides &lt;32" clear width, @ 29.5".</p>
