Minister & Schoolhouse Ponds

*2018 Vegetation Assessment, Water Quality Evaluation, and
Phragmites Management Report*

SOLITUDE
LAKE MANAGEMENT

Minister/Schoolhouse Pond
Eastham, Massachusetts

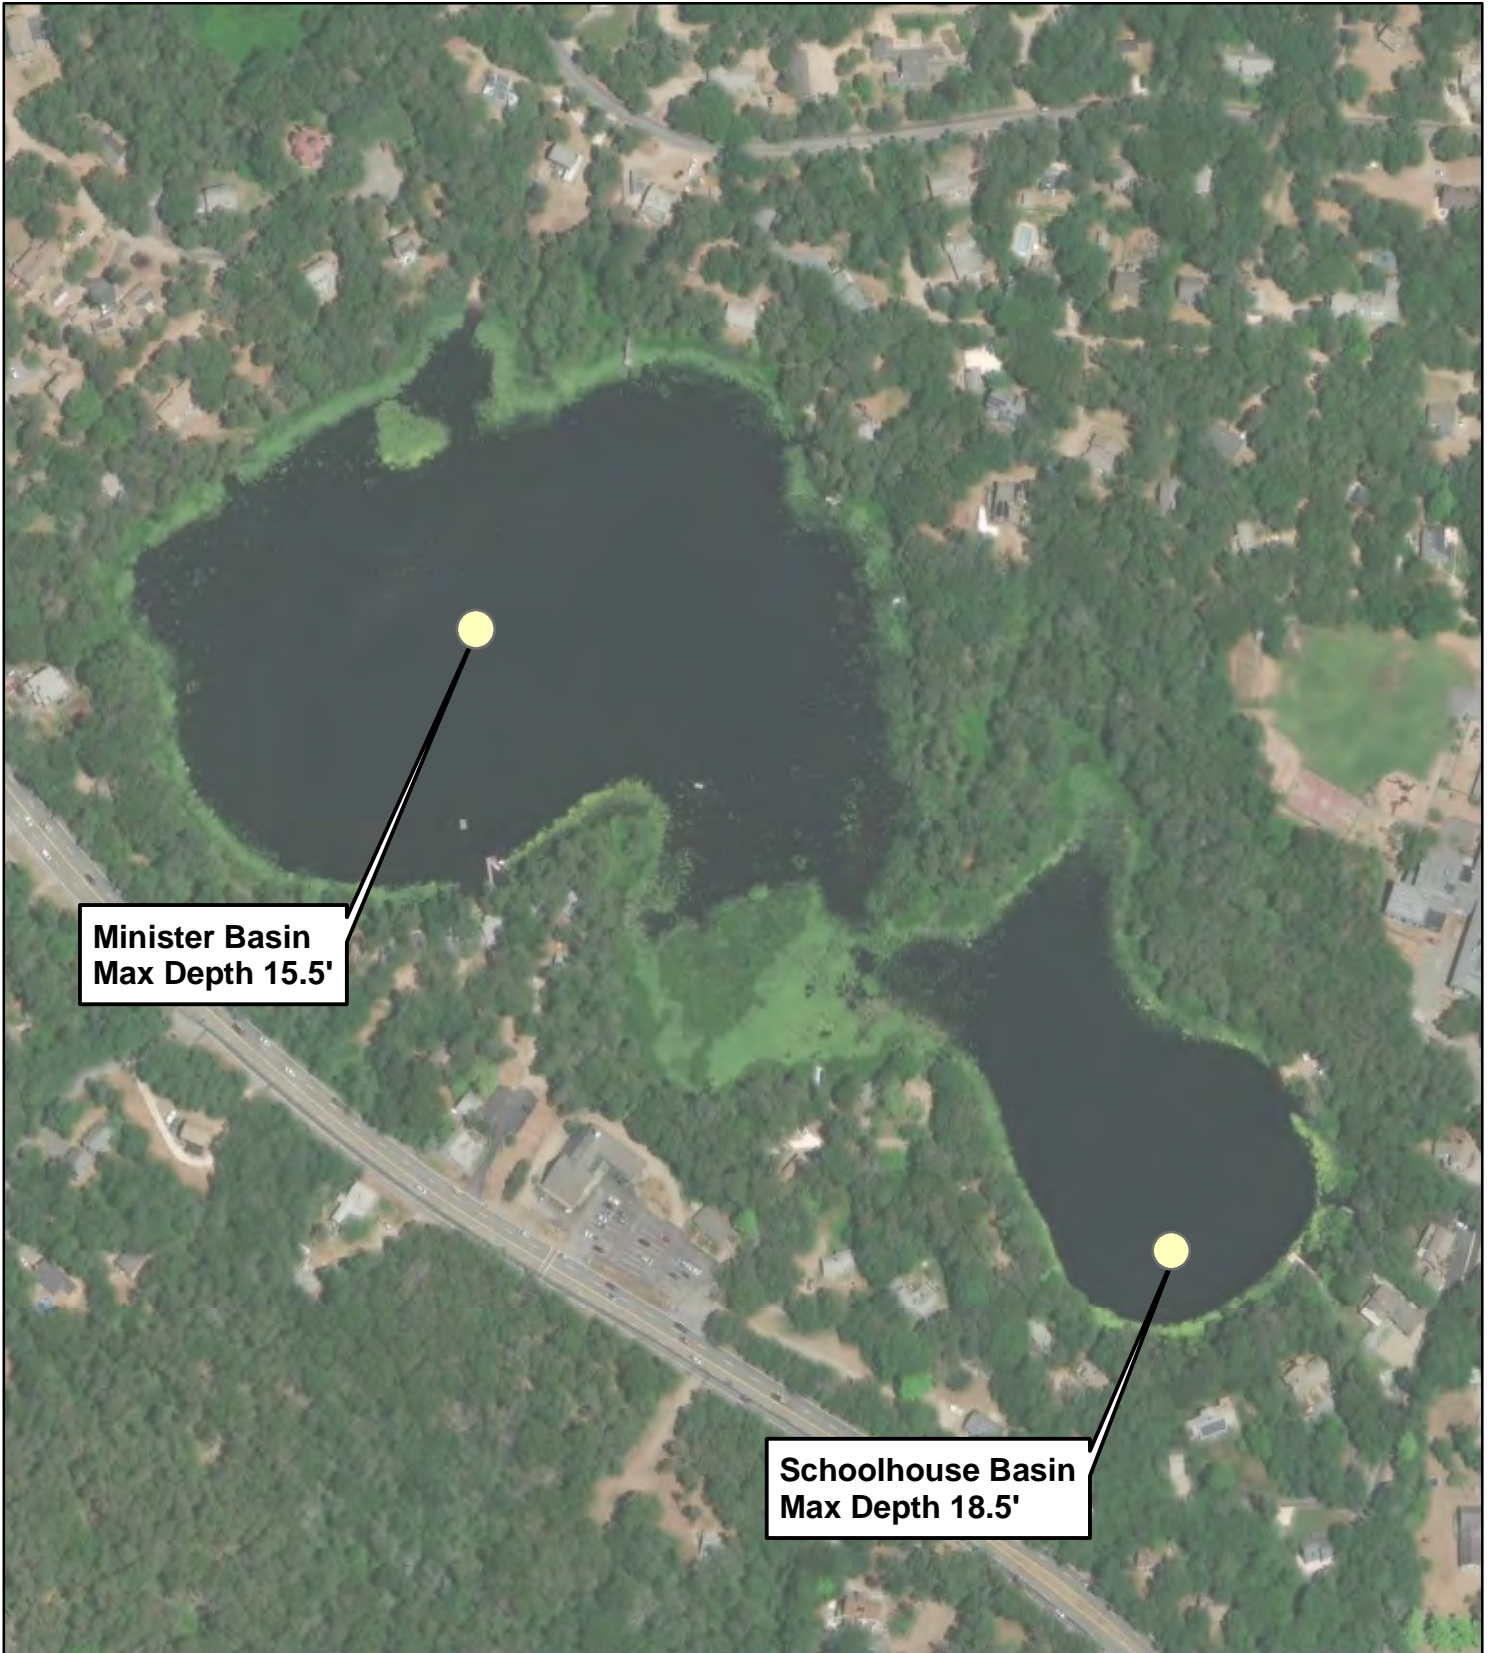
Water Chemistry Sample Locations

Two sampling sessions were conducted throughout the season: June 21st and July 24th (Table 2). A sampling location was visited in each basin at which two depths were sampled: 2ft and 2 feet above the relative bottom (Appendix B).

June 21 & July 24, 2018
