## EASTHAM BUILDING AUDITS

*KMA audited the following buildings:*

# TOWN HALL

*AUDITED ON: MAY 6, 2021*

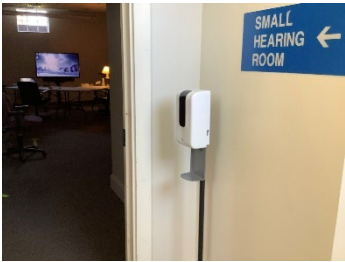
<p>Install an automatic door opener. Unit Cost: \$2,500 ea. Quantity: 1</p> <p>Insulate the pipes underneath the sink. Unit Cost: \$50 ea. Quantity: 2</p> <p>Lower the mirror. Unit Cost: \$50 ea. Quantity: 1</p>	<p>\$2,650</p>
<p>7.</p>	<p><b>Small Hearing Room (Lower Level)</b></p> <p>The door maneuvering clearance is &lt;18" on the latch pull-side for a forward approach, @ 16.5".</p>

<p>Install an automatic door opener. Unit Cost: \$2,500 ea. Quantity: 1</p>	<p>\$2,500</p>

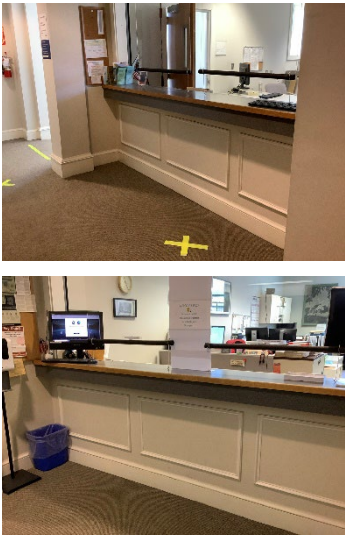
<p>Modify the sink to provide the required knee / toe clearance. Unit Cost: \$500 ea. Quantity: 1</p> <p>Provide an accessible cooktop. Unit Cost: \$750 ea. Quantity: 1</p>	<p>\$1,250</p>
<p>9.</p>	<p><b>Counters (First Floor)</b></p> <p>All the counters are &gt;36" AFF, @ 42" AFF. Computers are mounted &gt;36" AFF.</p>

<p>Lower a 36" portion of the counters to max. 36" AFF. Unit Cost: \$3,000 ea. Est. Quantity: 3</p>	<p>\$9,000</p>

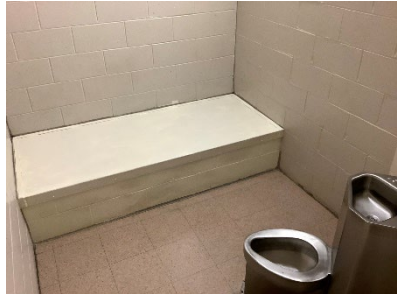
<p>Relocate the brochures within an accessible reach range.</p> <p>Unit Cost: \$250 Quantity: 3</p>	<p>\$750</p>
<p>7.</p>	<p><b>Holding Cells</b></p> <p>The sink lacks the required knee clearance for a forward approach.</p> <p>The toilet lacks the required grab bars.</p> <p><i>Note: At least one accessible cell per holding classifications must be provided.</i></p>

<p>Provide a compliant sink/toilet combo unit.</p> <p>Unit Cost: \$3,000 ea. Quantity: 1</p> <p>Install anti-ligature grab bars.</p> <p>Unit Cost: \$50 ea. Quantity: 2</p> <p>Develop a policy to utilize the accessible cell with the required turning space when needed. Ensure information about this policy is properly disseminated.</p> <p>Unit Cost: \$0 Quantity: N/A</p>	<p>\$3,100</p>
<p><b>TOTAL FOR POLICE STATION:</b></p>				<p><b>\$21,275</b></p>

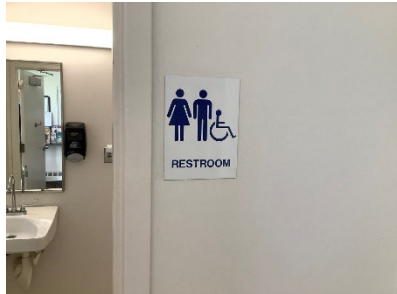
<p>3.</p>	<p><b>Public Single-User Toilet Room</b></p> <p>The door maneuvering clearance is &lt;18” on the latch pull-side for a forward approach due to the water cooler and other furniture elements.</p> <p>There is no tactile/ Braille signage mounted on the latch side of the door.</p> <p>The side grab bar extends &lt;54” from the rear wall, @ 49”.</p> <p>The toilet paper dispenser is not located 7”-9” from the front of the toilet.</p>

<p>Relocate the water cooler. Unit Cost: \$250 ea. Quantity: 1</p> <p>Install compliant tactile/ Braille signage on the latch side of the door. Coordinate with location and height requirements. Unit Cost: \$100 ea. Est. Quantity: 1</p> <p>Install a 42” min. side grab bar, located 12” from the interior corner of the wall. Unit Cost: \$50 ea. Quantity: 1</p> <p>Relocate the toilet paper dispenser. Unit Cost: \$50 ea. Quantity: 1</p>	<p>\$450</p>

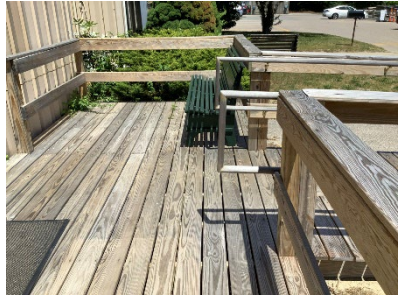
<p>Restripe the pavement markings in the parking space and associated access aisle. Unit Cost: \$150 per space or aisle Quantity: 2 (1 space + 1 aisle)</p> <p>Install a van accessible sign with the International Symbol of Accessibility at 60" AFF minimum, measured to the bottom of the sign. Unit Cost: \$100 ea. Quantity: 1</p>	\$400
2.	<p><b>Exterior Wooden Handrails</b></p> <p>The wooden handrail surfaces are abrasive, due to its deterioration.</p>

<p>Replace the handrails with compliant ones. Unit Cost: \$50/LF Est. Quantity: 130 LF</p>	\$6,500

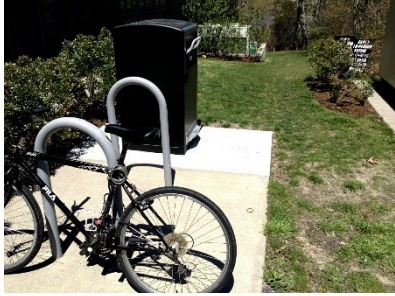
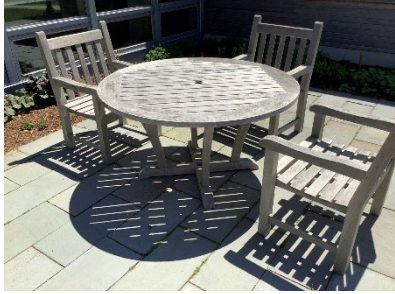
<p>3.</p>	<p><b>Outdoor Elements</b></p> <p>There is no accessible route to the trash due to the bicycle rack.</p> <p>There is no level 30" x 48" clear floor space adjacent to the trash, @ 30" x 34".</p> <p>The outdoor table located on the lower terrace is not accessible.</p>

<p>Relocate the trash to provide the required clear floor space along an accessible route. Unit Cost: \$250 ea. Quantity: 1</p> <p>Provide at least one table, and no less than 5% of the total number of tables, that provides compliant knee and toe clearance. Unit Cost: \$250 ea. Est. Quantity: 1</p>	<p>\$500</p>
<p>4.</p>	<p><b>Lower Terrace Door</b></p> <p>The door maneuvering clearance is &lt;12" on the latch push-side for a forward approach, @ 6".</p>

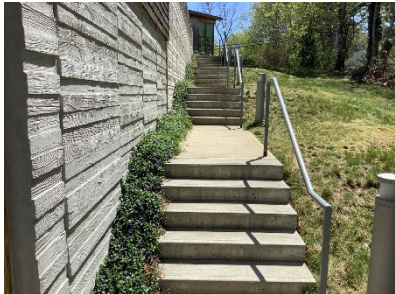
<p>Install an automatic door opener. Unit Cost: \$2,500 ea. Quantity: 1</p>	<p>\$2,500</p>
<p>5.</p>	<p><b>Outdoor Stairs</b></p> <p>The stair has a compliant handrail on only one side.</p>

<p>Install a compliant handrail on the second side. Unit Cost: \$50/LF Est. Quantity: 64 LF</p>	<p>\$3,200</p>

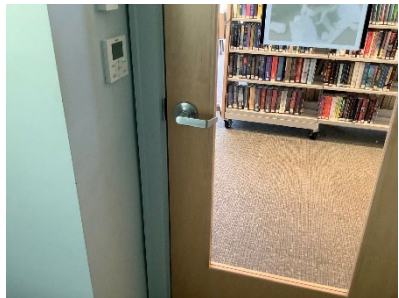
<p>Provide at least one computer table, and no less than 5% of the total number of tables, that provides compliant knee and toe clearance.</p> <p>Unit Cost: \$250 ea. Est. Quantity: 1</p> <p>Provide a computer within accessible reach range.</p> <p>Unit Cost: \$250 ea. Quantity: 1</p>	<p>\$500</p>
<p>7.</p>	<p><b>Door Maneuvering Clearance - Conference Room</b></p> <p>The door maneuvering clearance is &lt;18" on the latch pull-side for a forward approach, due to the recessed door.</p>

<p>Install an automatic door opener.</p> <p>Unit Cost: \$2,500 ea. Quantity: 1</p>	<p>\$2,500</p>

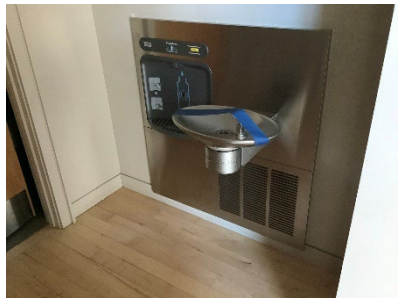
<p>Relocate the shelves to provide a compliant door maneuvering clearance.</p> <p>Unit cost: \$0</p> <p>Quantity: N/A</p>	<p>\$0</p>
<p>9.</p>	<p><b>Drinking Fountain</b></p> <p>There is no “hi” drinking fountain for standing persons provided.</p>

<p>Add a ‘hi’ drinking fountain per ADA-602.</p> <p>Unit Cost: \$1,000</p> <p>Quantity: 1</p>	<p>\$1,000</p>

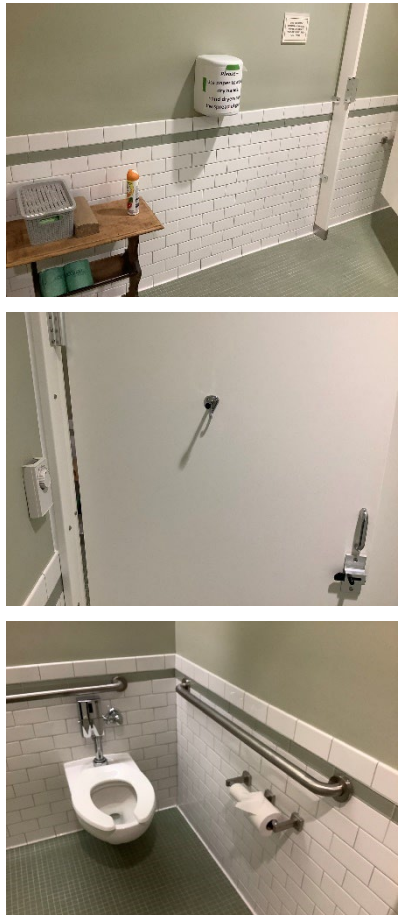
<p>Relocate the defibrillator box. Unit Cost: \$50 ea. Quantity: 1</p>	<p>\$50</p>
<p>11.</p>	<p><b>Women's Multi-user Toilet Room (Ground Floor)</b></p> <p>The paper towel dispenser protrudes &gt;4" at a height &gt;27" AFF, @ 7" at 39" AFF.</p> <p>The coat hook is mounted &gt;48" AFF, @ 54" AFF.</p> <p>The side grab bar extends &lt;54" from the rear wall, @ 48".</p> <p>The rear grab bar extends &lt;12" from the centerline of the water closet.</p>

<p>Relocate the paper towel dispenser. Unit Cost: \$50 ea. Quantity: 1</p> <p>Install a coat hook mounted no higher than 48" AFF. Unit Cost: \$50 ea. Quantity: 1</p> <p>Install a 42" min. side grab bar, located 12" from the interior corner of the wall. Unit Cost: \$50 ea. Quantity: 1</p> <p>Relocate the rear grab bar. Unit Cost: \$50 ea. Quantity: 1</p>	<p>\$200</p>

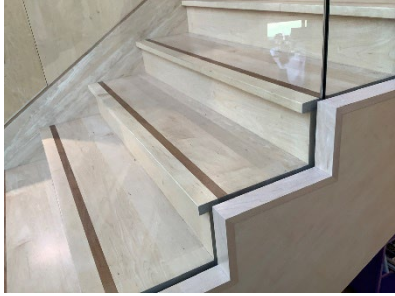
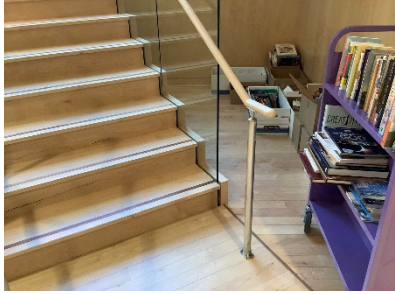
<p>14.</p>	<p><b>Stairs</b></p> <p>The stair nosings are “abrupt” as defined by 521 CMR.</p> <p>The bottom end of the handrail is not rounded nor returned to floor, wall, or post, as required by 521 CMR.</p>

<p>Install a strip under the nosing so that the underside has an angle not less than 60 degrees from horizontal. Unit Cost: \$50 ea. Est. Quantity: 20</p> <p>Install a compliant handrail extension on the bottom of the stair. Unit Cost: \$50/LF Est. Quantity: 4LF</p>	<p>\$1,200</p>
<p>15.</p>	<p><b>Program Room #006</b></p> <p>The sink lacks the required knee and toe clearance for a forward approach.</p>

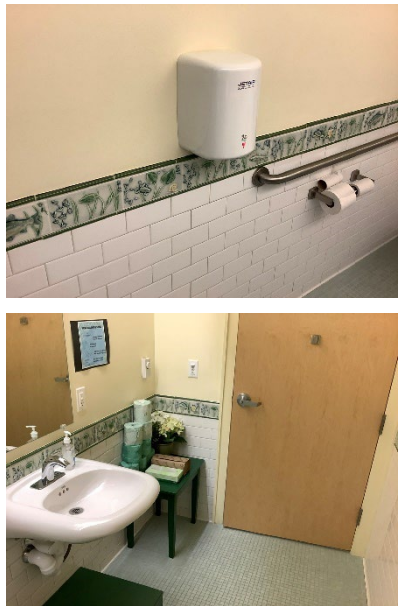
<p>16.</p>	<p><b>Single-user Toilet Room (Lower Floor)</b></p> <p>The toilet paper dispenser protrudes &gt;4" at a height &gt;27" AFF, @ 7" at 39" AFF.</p> <p>The door lacks the required maneuvering clearance on the latch pull-side for a forward approach, due to the sink.</p>

<p>Relocate the toilet paper dispenser. Unit Cost: \$50 ea. Quantity: 1</p> <p>Install an automatic door opener. Unit Cost: \$2,500 ea. Quantity: 1</p>	<p>\$2,550</p>
<p><b>TOTAL FOR PUBLIC LIBRARY:</b></p>				<p><b>\$20,250</b></p>

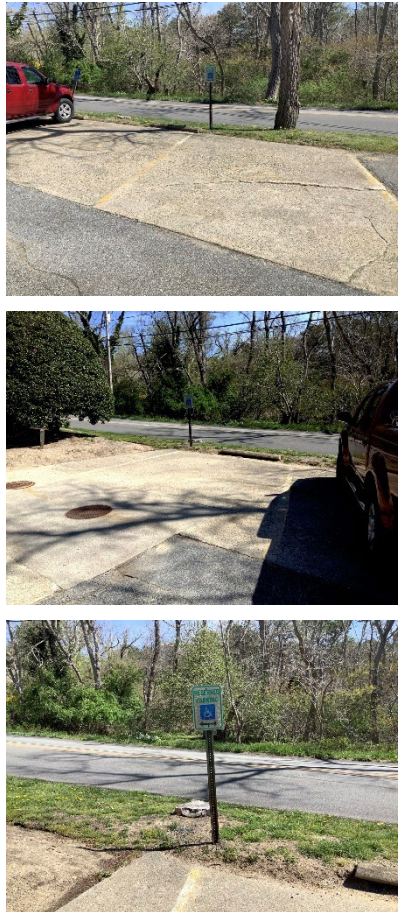
#	Barrier Statement	Photo	Proposed Mitigation	Cost
1.	<p><b>Lower Parking Lot</b></p> <p>The pavement markings in the designated parking spaces are not visible.</p> <p>The designated accessible parking spaces lack an adjacent access aisle.</p> <p>There is an insufficient number of van accessible parking spaces. For a parking lot with 4 accessible spaces, 1 must be van accessible.</p> <p>The parking spaces have changes in level &gt;1/4" due to variations in the paver surface and sewer covers.</p> <p>The accessible parking signs are mounted &lt;60" AFF, measured to the bottom of the sign.</p>

<p>Regrade and restripe the existing accessible parking spaces and associated access aisles. Unit Cost: \$1,500 per space or aisle Quantity: 6 (4 spaces + 2 aisles)</p> <p>Restripe a portion of the parking lot to add 1 van accessible space, as well as its associated sign and access aisle. Unit Cost: \$300 per space or aisle Quantity: 2 (1 space + 1 aisle)</p> <p>Install a sign with the International Symbol of Accessibility at 60" AFF minimum, measured to the bottom of the sign. Include a van accessible sign where applicable. Unit Cost: \$100 ea. Quantity: 5</p>	\$10,100

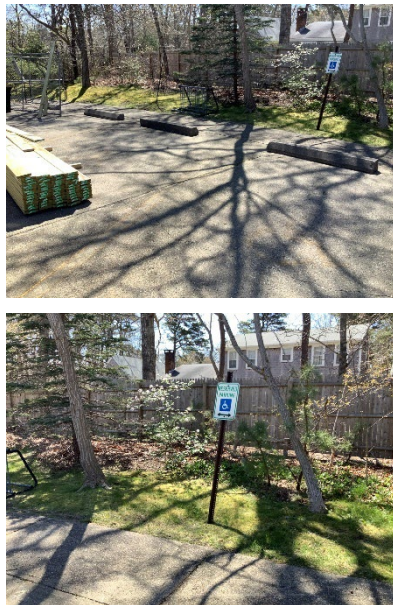
<p>2.</p>	<p><b>Upper Parking Lot</b></p> <p>The pavement markings in the designated parking spaces are not visible.</p> <p>The designated accessible parking spaces lack an adjacent access aisle.</p> <p>There is an insufficient number of van accessible parking spaces. For a parking lot with 3 accessible spaces, 1 must be van accessible.</p> <p>Some of the accessible parking spaces have slopes &gt;2%, @ 3%.</p> <p>The accessible parking signs are mounted &lt;60" AFF, @ 50" AFF measured to the bottom of the sign.</p>

<p>Regrade and restripe the existing accessible parking space and associated access aisle. Unit Cost: \$1,500 per space or aisle Quantity: 2 (1 space, 1 aisle)</p> <p>Restripe the existing accessible parking spaces and associated access aisles. Add 1 van accessible space, as well as its associated sign and access aisle. Unit Cost: \$1,500 per space or aisle Quantity: 5 (3 spaces, 2 aisle)</p> <p>Install a sign with the International Symbol of Accessibility at 60" AFF minimum, measured to the bottom of the sign. Include a van accessible sign where applicable. Unit Cost: \$100 ea. Quantity: 4</p>	<p>\$10,900</p>

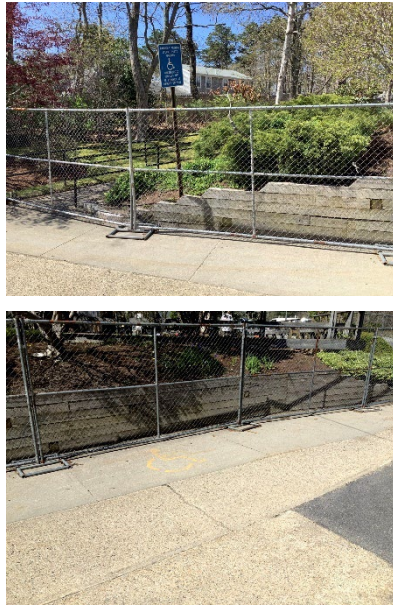
<p>3.</p>	<p><b>Dropoff Parking</b></p> <p>The pavement markings in the designated parking spaces are not visible.</p> <p>The designated accessible parking spaces lack an adjacent access aisle.</p> <p>There is an insufficient number of van accessible parking spaces. For a parking lot with 2 accessible spaces, 1 must be van accessible.</p> <p>The accessible parking spaces have slopes &gt;2%, @ 4.5%.</p>

<p>Regrade and restripe the existing accessible parking spaces and associated access aisles. Unit Cost: \$1,500 per space or aisle Quantity: 4 (2 spaces, 2 aisles)</p> <p>Restripe a portion of the parking lot to add 1 van accessible space, as well as its associated sign and access aisle. Unit Cost: \$300 per space or aisle Quantity: 2 (1 space, 1 aisle)</p>	<p>\$6,600</p>

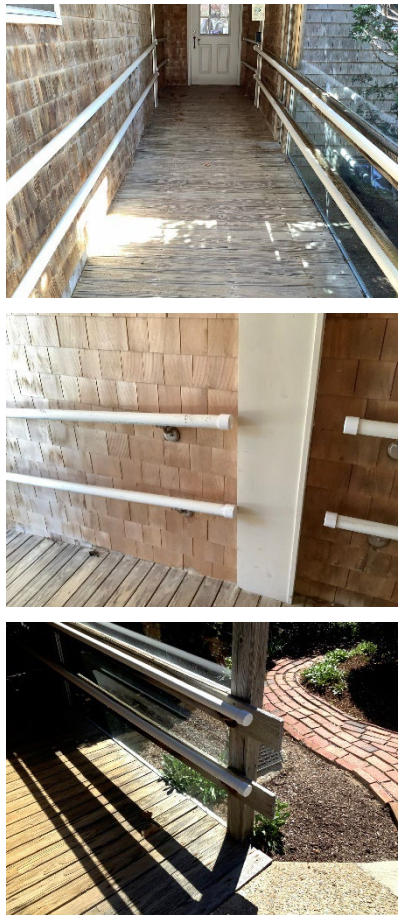
<p>7.</p>	<p><b>Secondary Entrance at Reception Area</b></p> <p>The top half of the ramp has running slopes &gt;8.3%, @ 9%.</p> <p>The ramp lacks the required upper and lower handrail extensions.</p> <p>The bottom ends of the handrails are neither rounded nor returned to floor, wall, or post, as required by 521 CMR.</p> <p>The handrails are not continuous.</p> <p>The ramp handrails are not mounted 34"-38" AFF, @ 33" AFF.</p>

<p>Rebuild the ramp, including compliant handrails.</p> <p>Unit Cost: \$15,000 ea.</p> <p>Quantity: 1</p>	<p>\$15,000</p>
<p>8.</p>	<p><b>Secondary Entrance at Ground Floor Hallway</b></p> <p>The inaccessible secondary entrance (C) lacks directional signage to the accessible entrance.</p> <p>The bottom ends of the handrails are neither rounded nor returned to floor, wall, or post, as required by 521 CMR.</p>

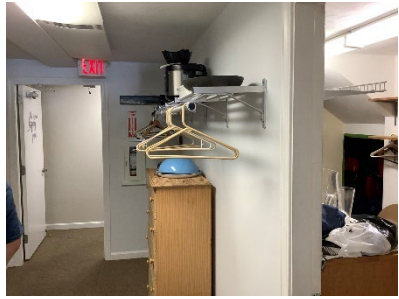
<p>9.</p>	<p><b>Outdoor Stairs</b></p> <p>The stair lacks the required upper and lower handrail extensions.</p> <p>The stair handrails are not mounted 34"-38" AFF, @ 29" AFF.</p> <p>The stair nosings are "abrupt" as defined by 521 CMR.</p> <p>The stair has open risers.</p>	 	<p>Install compliant handrails on both sides of the stair.</p> <p>Unit Cost: \$50/LF Est. Quantity: 32 LF</p> <p>Install compliant riser boards.</p> <p>Unit Cost: \$25 ea. Est. Quantity: 20</p>	<p>\$2,100</p>
<p>10.</p>	<p><b>Main Entrance</b></p> <p>The threshold is <math>&gt;1/2</math>" and not beveled at maximum 1:2.</p>	 	<p>Replace the threshold.</p> <p>Unit Cost: \$250 ea. Quantity: 1</p>	<p>\$250</p>
<p>11.</p>	<p><b>Protruding Objects (Lower Ground Floor)</b></p> <p>The wall mounted shelf protrudes <math>&gt;4</math>" at a height <math>&gt;27</math>" AFF into the circulation path.</p> <p>The headroom under the ventilation system provides <math>&lt;80</math>" of vertical clearance, @ 77" AFF.</p>

<p>Relocate the shelf.</p> <p>Unit Cost: \$50 ea. Quantity: 1</p> <p>Install a cane detectable object below the ventilation system.</p> <p>Unit Cost: \$250 ea. Quantity: 1</p>	<p>\$300</p>

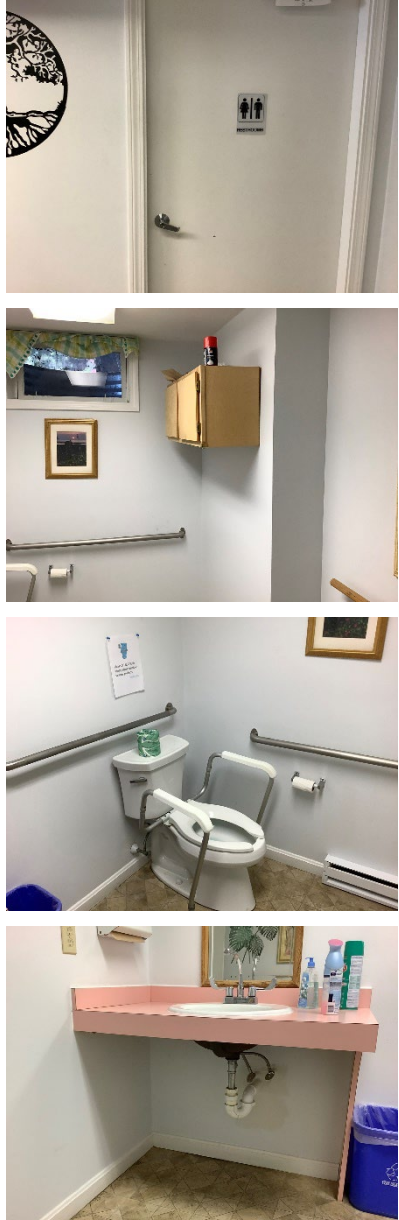
<p>12.</p>	<p><b>Single-user Toilet Room #1 (Lower Ground Floor)</b></p> <p>The door lacks tactile/ braille signage mounted on the latch side of the door.</p> <p>The door maneuvering clearance is &lt;18” on the latch pull-side for a forward approach, @ 5.5”.</p> <p>The wall-mounted cabinet protrudes &gt;4” at a height &gt;27” AFF, @ 12” at 60” AFF.</p> <p>The side grab bar starts &gt;12” from the rear wall, @ 19.5”</p> <p>The side grab bar is not mounted 33”-36” AFF, @ 31.5” AFF.</p> <p>The toilet paper dispenser is not located 7”-9” from the front of the toilet.</p> <p>The sink has pipes that are not insulated.</p>

<p>Install compliant tactile/ Braille signage on the latch side of the door. Coordinate with location and height requirements. Unit Cost: \$100 ea. Est. Quantity: 1</p> <p>Install an automatic door opener. Unit Cost: \$2,500 ea. Quantity: 1</p> <p>Relocate the wall-mounted cabinet. Unit Cost: \$50 ea. Quantity: 1</p> <p>Relocate the side grab bar. Unit Cost: \$50 ea. Quantity: 1</p> <p>Relocate the toilet paper dispenser. Unit Cost: \$50 ea. Quantity: 1</p> <p>Insulate the pipes. Unit Cost: \$50 ea. Quantity: 1</p>	<p>\$2,800</p>

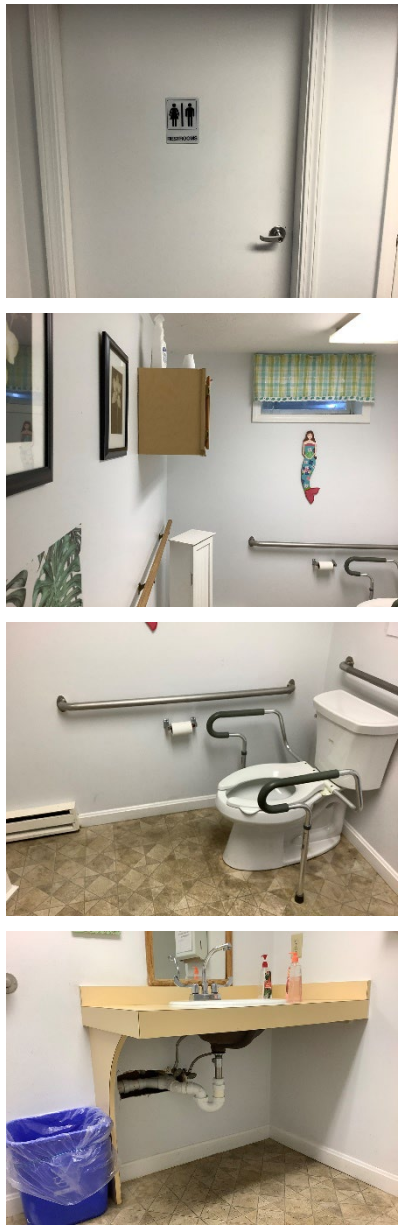
<p>13.</p>	<p><b>Single-user Toilet Room #2 (Lower Ground Floor)</b></p> <p>The door lacks tactile/ braille signage mounted on the latch side of the door.</p> <p>The door maneuvering clearance is &lt;18” on the latch pull-side for a forward approach, @ 5.5”.</p> <p>The wall-mounted cabinet protrudes &gt;4” at a height &gt;27” AFF, @ 12” at 60” AFF.</p> <p>The side grab bar is not mounted 33”-36” AFF, @ 31.5” AFF.</p> <p>The toilet paper dispenser is not located 7”- 9” from the front of the toilet.</p> <p>The flush valve is not located on the open side of the toilet.</p> <p>The sink has pipes that are not insulated.</p> <p>The coat hook is mounted &gt;48” AFF.</p>

<p>Install compliant tactile/ Braille signage on the latch side of the door. Coordinate with location and height requirements. Unit Cost: \$100 ea. Est. Quantity: 1</p> <p>Install an automatic door opener. Unit Cost: \$2,500 ea. Quantity: 1</p> <p>Relocate the wall-mounted cabinet. Unit Cost: \$50 ea. Quantity: 1</p> <p>Relocate the side grab bar. Unit Cost: \$50 ea. Quantity: 1</p> <p>Relocate the toilet paper dispenser. Unit Cost: \$50 ea. Quantity: 1</p> <p>Relocate the flush valve or install an automatic flush control. Unit Cost: \$1,000 ea. Quantity: 1</p> <p>Insulate the pipes. Unit Cost: \$50 ea. Quantity: 1</p> <p>Install a coat hook mounted no higher than 48” AFF. Unit Cost: \$50 ea. Quantity: 1</p>	<p>\$3,850</p>

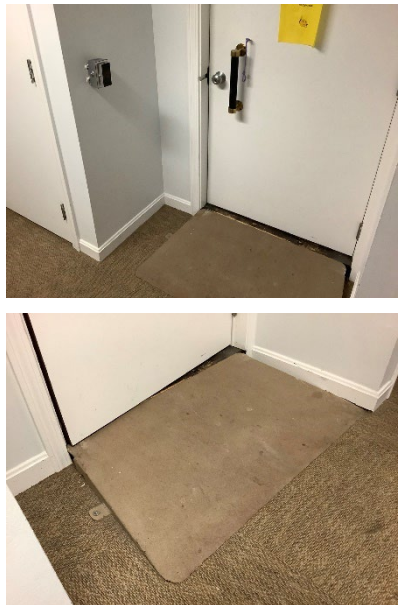
<p>14.</p>	<p><b>Lift</b></p> <p>There is no level 30" x 48" clear floor space adjacent to the lift control due to the removable ramp.</p> <p>The door maneuvering clearance is &lt;18" on the latch pull-side for a forward approach, @</p>

<p>Relocate the control. Unit Cost: \$250 ea. Quantity: 1</p> <p>Install an automatic door opener. Unit Cost: \$2,500 ea. Quantity: 1</p>	<p>\$2,750</p>
<p>15.</p>	<p><b>Stairs</b></p> <p>The stair lacks the required upper and lower handrail extensions.</p> <p>The bottom ends of the handrails are neither rounded nor returned to floor, wall, or post, as required by 521 CMR.</p> <p>The handrails are not continuous.</p>

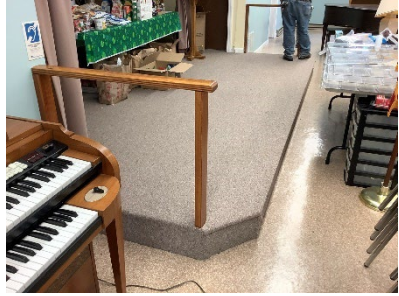
<p>16.</p>	<p><b>Stage (Ground Floor)</b></p> <p>No accessible route is provided to the stage due to the 8" step.</p>

<p>Build a ramp. Unit Cost: \$5,000 ea. Quantity: 1</p>	<p>\$5,000</p>
<p>17.</p>	<p><b>Service Counter (Ground Floor)</b></p> <p>The service counter is &gt;36" AFF, @ 43" AFF.</p>

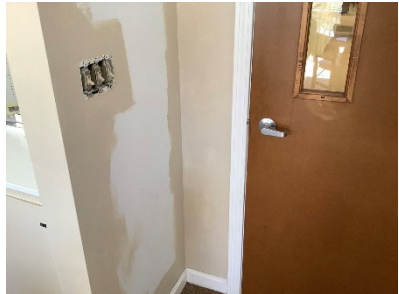
<p>Provide at least one computer in an accessible room. Unit Cost: \$0. Quantity: N/A</p>	<p>\$0</p>
<p>19.</p>	<p><b>Common Room (Ground Floor)</b></p> <p>The door maneuvering clearance is &lt;18" on the latch pull-side for a forward approach, @ 12".</p>

<p>Install an automatic door opener. Unit Cost: \$2,500 ea. Quantity: 1</p>	<p>\$2,500</p>

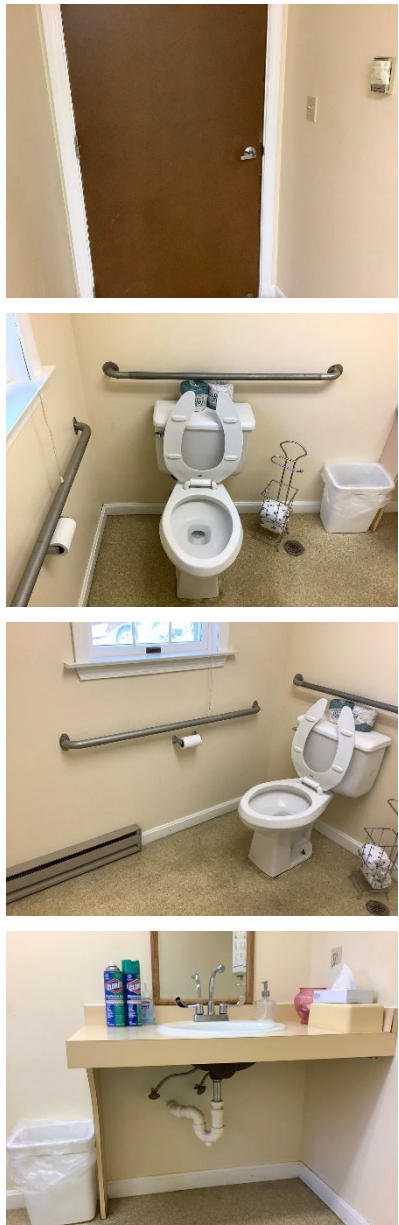
<p>20.</p>	<p><b>Single-user Toilet Room #3 (Ground Floor)</b></p> <p>The door lacks tactile/ braille signage mounted on the latch side of the door.</p> <p>The door maneuvering clearance is &lt;18” on the latch pull-side for a forward approach, @ 4.5”.</p> <p>The side grab bar is mounted &lt;33” AFF.</p> <p>The rear grab bar is mounted &gt;36” AFF.</p> <p>The toilet paper dispenser is not located 7”- 9” from the front of the toilet.</p> <p>The toilet centerline is &gt;18” from the wall, @ 22”.</p> <p>The flush valve is not located on the open side of the toilet.</p> <p>The sink has pipes that are not insulated.</p> <p>The coat hook is mounted &gt;48” AFF.</p>

<p>Install compliant tactile/ Braille signage on the latch side of the door. Coordinate with location and height requirements. Unit Cost: \$100 ea. Est. Quantity: 1</p> <p>Install an automatic door opener. Unit Cost: \$2,500 ea. Quantity: 1</p> <p>Relocate the side and rear grab bars. Unit Cost: \$50 ea. Quantity: 2</p> <p>Relocate the toilet paper dispenser. Unit Cost: \$50 ea. Quantity: 1</p> <p>Reposition the toilet. Unit Cost: \$1,500 ea. Quantity: 1</p> <p>Reposition the flush valve or install an automatic flush control. Unit Cost: \$1,000 ea. Quantity: 1</p> <p>Insulate the pipes. Unit Cost: \$50 ea. Quantity: 1</p> <p>Install a coat hook mounted no higher than 48” AFF. Unit Cost: \$50 ea. Quantity: 1</p>	<p>\$5,350</p>

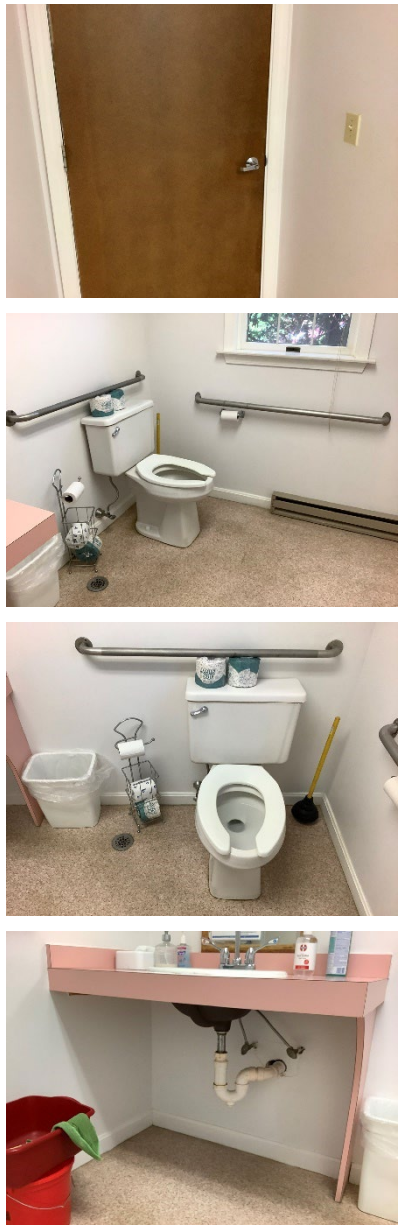
<p>21.</p>	<p><b>Single-user Toilet Room #4 (Ground Floor)</b></p> <p>The door lacks tactile/ braille signage mounted on the latch side of the door.</p> <p>The door maneuvering clearance is &lt;18” on the latch pull-side for a forward approach, @ 4.5”.</p> <p>The side grab bar is mounted &lt;33” AFF.</p> <p>The rear grab bar is mounted &gt;36” AFF.</p> <p>The toilet paper dispenser is not located 7”- 9” from the front of the toilet.</p> <p>The toilet centerline is &gt;18” from the wall, @ 21.5”.</p> <p>The sink has pipes that are not insulated.</p> <p>The coat hook is mounted &gt;48” AFF.</p>

<p>Install compliant tactile/ Braille signage on the latch side of the door. Coordinate with location and height requirements. Unit Cost: \$100 ea. Est. Quantity: 1</p> <p>Install an automatic door opener. Unit Cost: \$2,500 ea. Quantity: 1</p> <p>Relocate the side and rear grab bars. Unit Cost: \$50 ea. Quantity: 2</p> <p>Relocate the toilet paper dispenser. Unit Cost: \$50 ea. Quantity: 1</p> <p>Reposition the toilet. Unit Cost: \$1,500 ea. Quantity: 1</p> <p>Insulate the pipes. Unit Cost: \$50 ea. Quantity: 1</p> <p>Install a coat hook mounted no higher than 48” AFF. Unit Cost: \$50 ea. Quantity: 1</p>	<p>\$4,300</p>

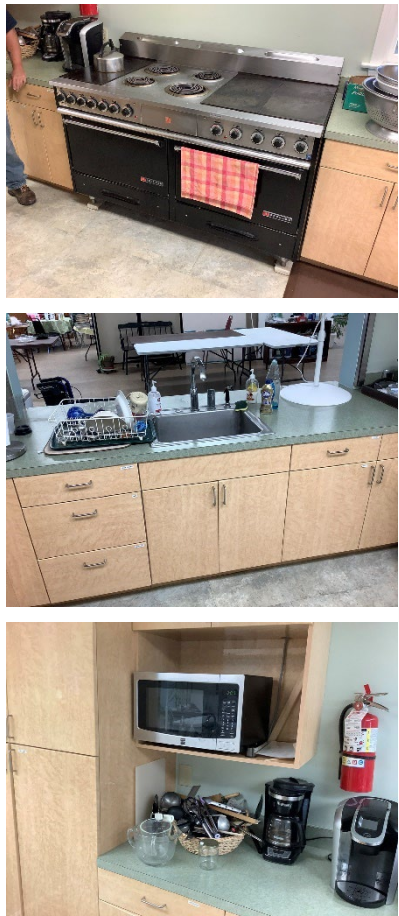
<p>22.</p>	<p><b>Kitchen (Ground Floor)</b></p> <p>The sink counter is &gt;34" AFF, @ 36" AFF</p> <p>The sink lacks the required knee and toe clearance for a forward approach.</p> <p>The cooktop is &gt;34" AFF, @ 36" AFF.</p> <p>The cooktop lacks the required knee and toe clearance for a forward approach.</p> <p>The microwave controls are mounted &gt;48" AFF.</p> <p>The phone is mounted &gt;48" AFF.</p> <p>The door hardware requires tight grasping, pinching, or twisting of the wrist to operate.</p>

<p>Lower the counter to 34" AFF maximum. Unit Cost: \$3,000 ea. Quantity: 1</p> <p>Provide an accessible sink with the required knee and toe clearance. Unit Cost: \$750 ea. Quantity: 1</p> <p>Provide an accessible cooktop with the required knee and toe clearance. Unit Cost: \$750 ea. Quantity: 1</p> <p>Relocate the microwave. Unit Cost: \$250 Quantity: 1</p> <p>Relocate the phone. Unit Cost: \$250 Quantity: 1</p> <p>Replace the door hardware with lever type. Unit Cost: \$300 ea. Quantity: 1</p>	<p>\$5,300</p>

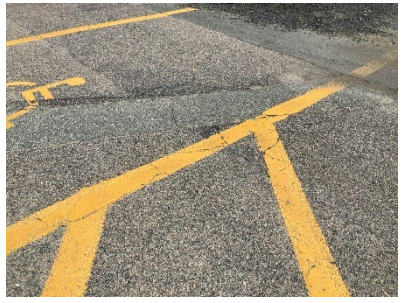
#	<i>Barrier Statement</i>	<i>Photo</i>	<i>Proposed Mitigation</i>	<i>Cost</i>
1.	<p><b>Sticker Office Parking Lot</b></p> <p>The parking space has changes in level &gt;1/4" due to variations in the paver surface.</p>

<p>Regrade and restripe the existing accessible parking space.</p> <p>Unit Cost: \$1,500 per space or aisle</p> <p>Quantity: 1</p>	\$1,500
2.	<p><b>Ramp to the Sticker Office (older one)</b></p> <p>The top half of the ramp has running slopes &gt;8.3%, @ 8.8%.</p> <p>The ramp lacks the required handrails.</p>

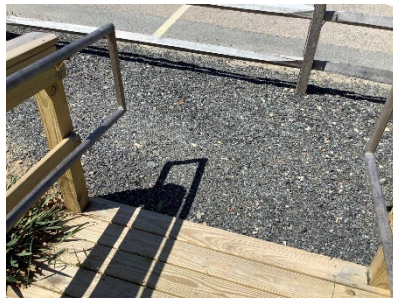
<p>3.</p>	<p><b>Ramp to the Sticker Office (newest)</b></p> <p>No accessible route from the driveway to the ramp is provided due to the gravel surface.</p>

<p>Construct an accessible route. Unit Cost: \$25/SF Est. Quantity: 30 SF</p>	<p>\$750</p>
<p>4.</p>	<p><b>Outdoor Elements</b></p> <p>The service counter protrudes &gt;4” at a height &gt;27” AFF, @ 11” at 33” AFF.</p> <p>The separation screen protrudes &gt;4” at a height &gt;27” AFF.</p>

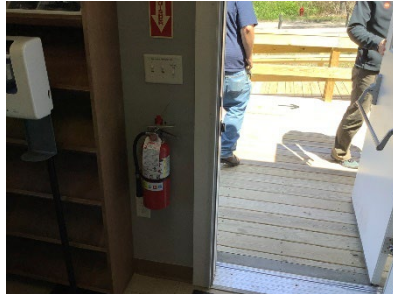
<p>Install a cane detectable object below the counter and the separation screen. Unit Cost: \$250 ea. Quantity: 2</p>	<p>\$500</p>
<p>5.</p>	<p><b>Sticker Office Entrance Door</b></p> <p>The door lacks the required maneuvering clearance on the latch push-side, for a forward approach, due to the presence of furniture elements and fire extinguisher.</p>

<p>Relocate the shelf and fire extinguisher to provide a compliant door maneuvering clearance. Unit cost: \$0 Quantity: N/A</p>	<p>\$0</p>

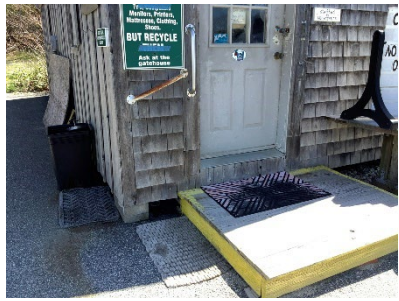
<p>8.</p>	<p><b>“Stock Exchange” Secondary Entrance</b></p> <p>The inaccessible secondary entrance lacks directional signage to the accessible entrance.</p> <p>The stair lacks the required handrails.</p>

<p>Provide directional signage to the accessible entrance.</p> <p>Unit Cost: \$100 ea. Est. Quantity: 1</p> <p>Install compliant handrails on both sides of the stair.</p> <p>Unit Cost: \$50/LF Est. Quantity: 8 LF</p>	<p>\$500</p>
<p>9.</p>	<p><b>“Stock Exchange” Secondary Entrance Door</b></p> <p>The door hardware and locker require tight grasping, pinching, or twisting of the wrist to operate.</p>

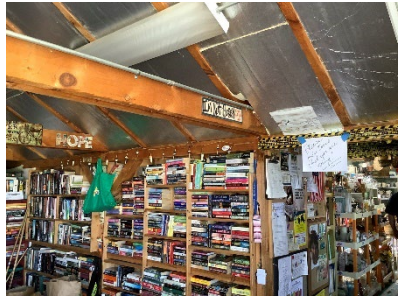
<p>Replace the door locker and hardware.</p> <p>Unit Cost: \$300 ea. Quantity: 2</p>	<p>\$600</p>
<p>10.</p>	<p><b>“Stock Exchange” Interior Headroom</b></p> <p>The headroom under the wooden beam and door frame provides &lt;80” of vertical clearance, @ 77” – 73” AFF.</p>

<p>Provide signage at the building entrance and information on the website alerting visitors and their companions about the low headroom.</p> <p>Unit Cost: \$0</p>	<p>\$0</p>

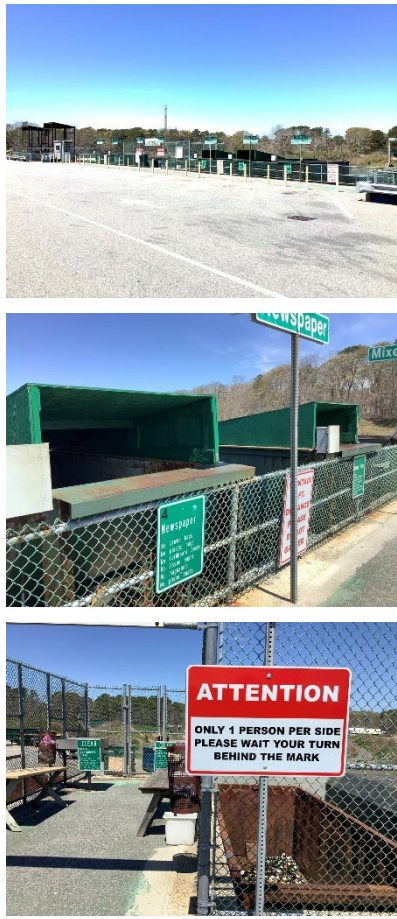
<p>11.</p>	<p><b>Recycling Station (Plastic, Glass, Newspaper, etc.)</b></p> <p>Currently, no standard accessible parking spaces and no van accessible parking spaces are provided.</p> <p>The openings to the trash containers are &gt; 48" AFF.</p> <p>The sign protrudes &gt;4", @ 17" into the circulation path.</p>

<p>Restripe a portion of the parking lot to add 1 van accessible parking space as well as its associated sign and access aisle. Unit Cost: \$300 per space or aisle Quantity: 2 (1 space, 1 aisle)</p> <p>Establish a policy for assisting residents who are unable to reach the openings to the trash containers. Unit Cost: \$0 Quantity: N/A</p> <p>Relocate the sign. Unit Cost: \$50 ea. Quantity: 1</p>	<p>\$650</p>
<p><b>TOTAL FOR TRANSFER STATION / RECYCLING FACILITY:</b></p>				<p><b>\$35,050</b></p>
